# Village of Hilton Beach

## Asset Management Plan — Phases One and Two

## **VISUAL BUILDING CONDITION ASSESSMENT**

**3100 Bowker Street, Municipal Office, Village  
of Hilton Beach, Ontario**

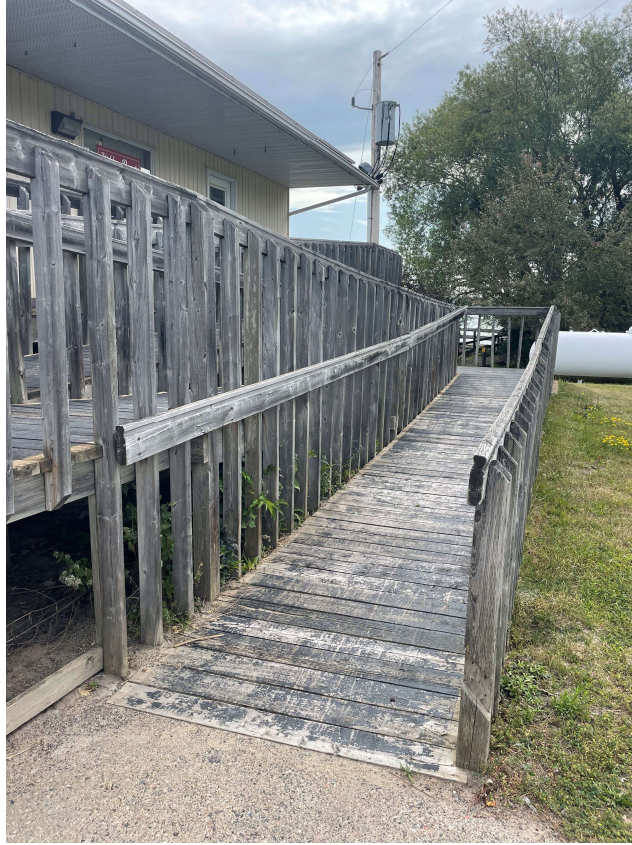
- The asphalt shingles were heavily stained by moss and organics.
- The wooden stairs and ramps servicing Canada Post were assumed to be 20 years old and were in very poor condition.
- The “Duradek” membrane topping on the elevated patio appeared weathered, but no perforations were noted.

**Photo 3: Weathered and Decayed Wood Ramp at Entrance to Canada Post**

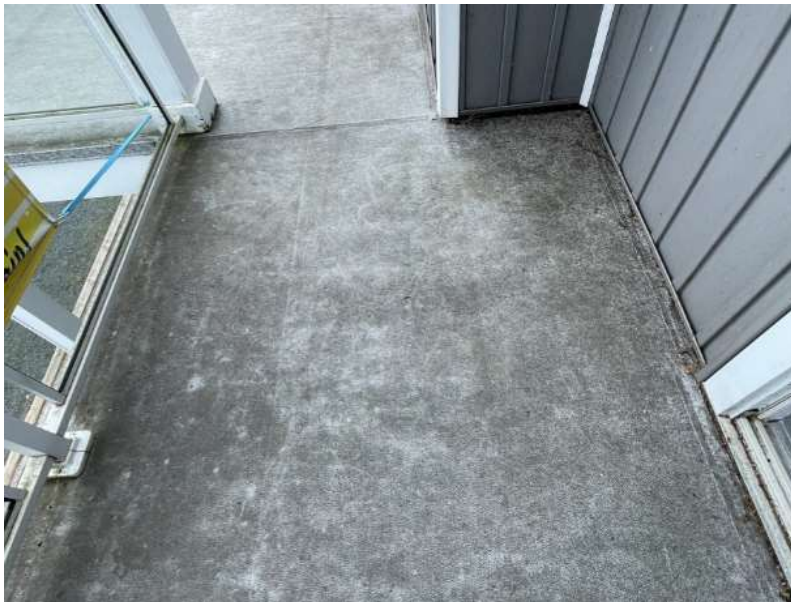
**Photo 4: Membrane on Patio**

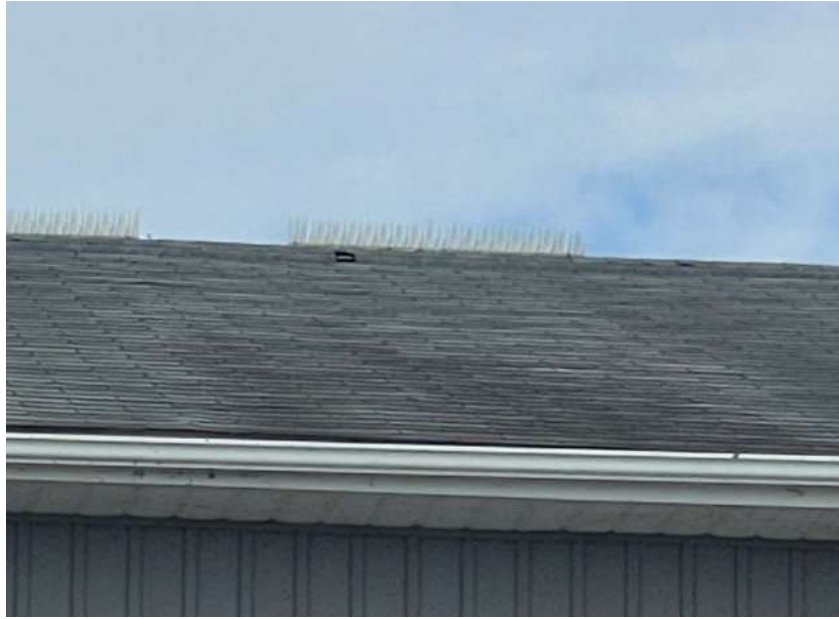
**Photo 5: Heavy Organic Staining on Asphalt Shingles**

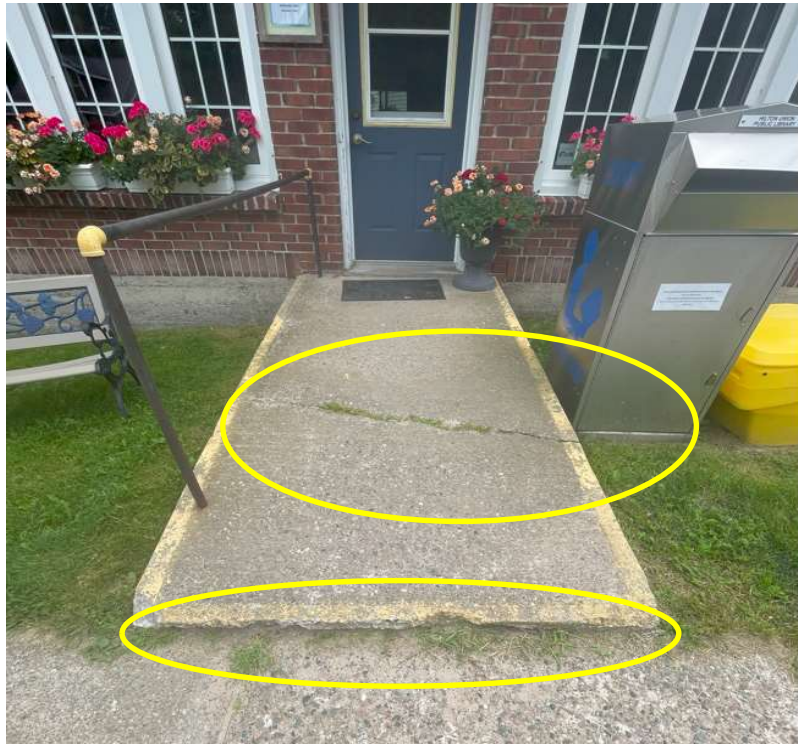
**Photo 4: Main Entrance Concrete Ramp with Step and Large Crack**

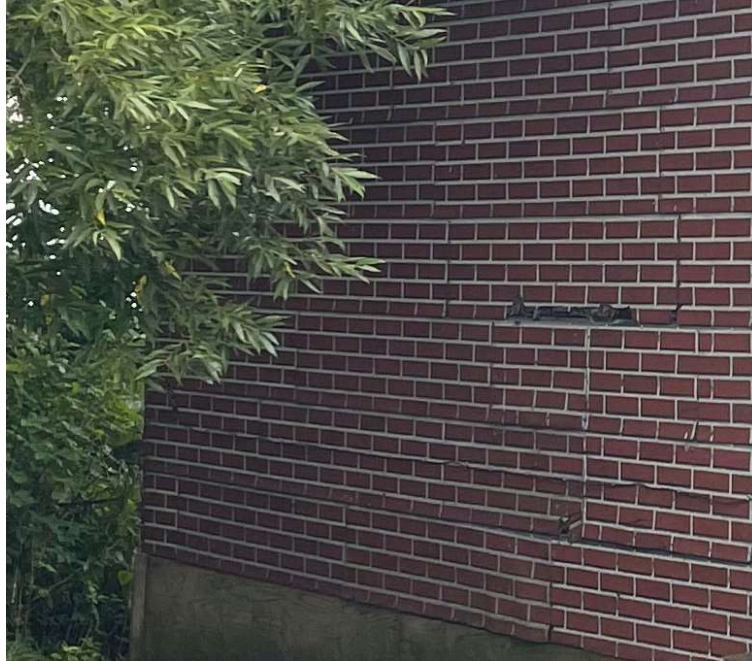
**Photo 5: Asphalt Brick Siding Panels**

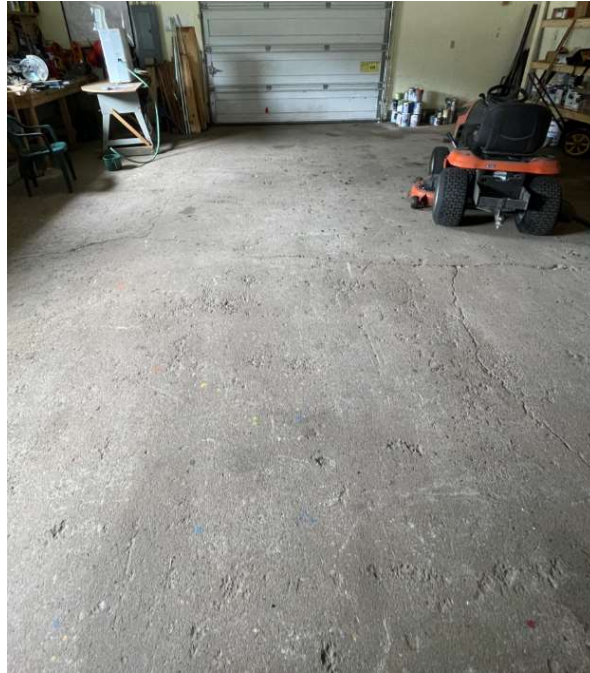
- The floor slab was noted to be extensively cracked with heavy spalling throughout.
- The asphalt shingles were noted to be in very poor condition.

**Photo 5: Extensively Cracked and Spalled Concrete Floor Slab**

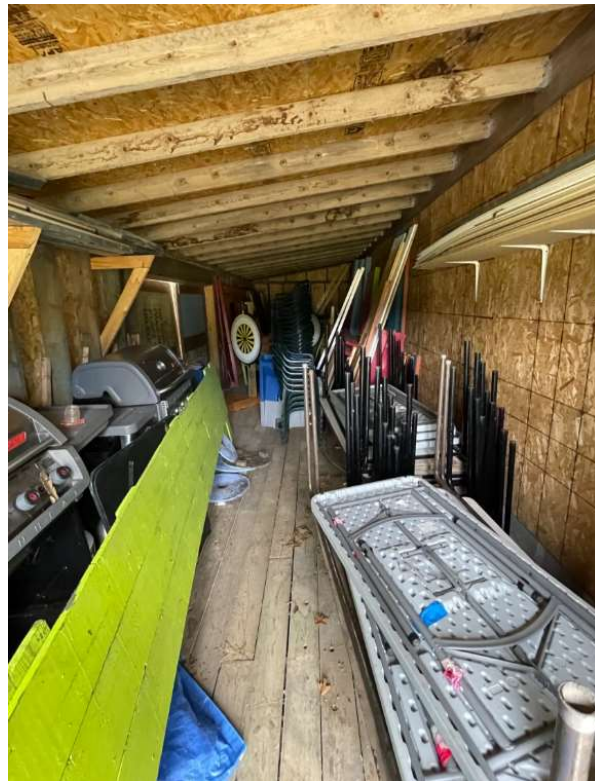
**Photo 6: Interior of Lean-to on Original Garage**

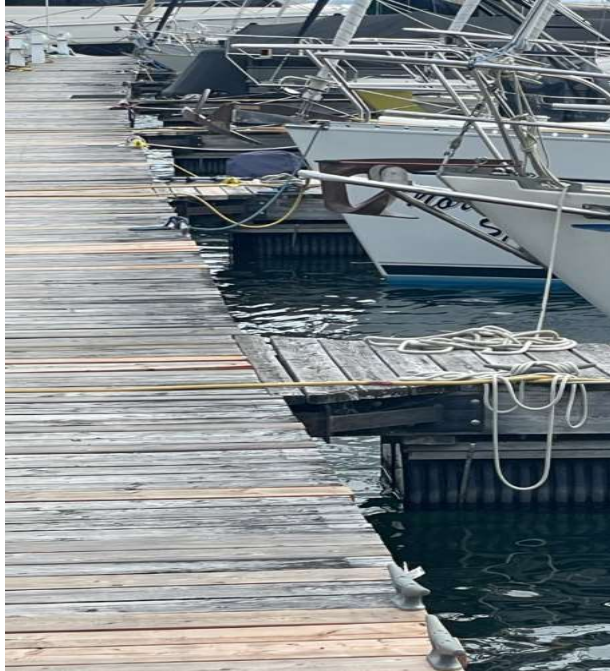
- The remaining lifespan of the wood on the dock surfaces is less than five years.

**Photo 4: Dock Infrastructure**

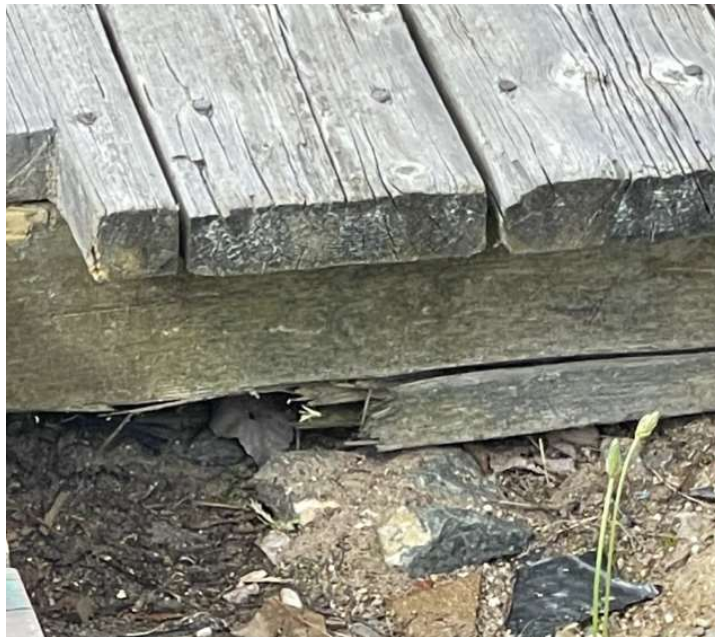
**Photo 5: Deteriorated Wood Construction on Boardwalk**

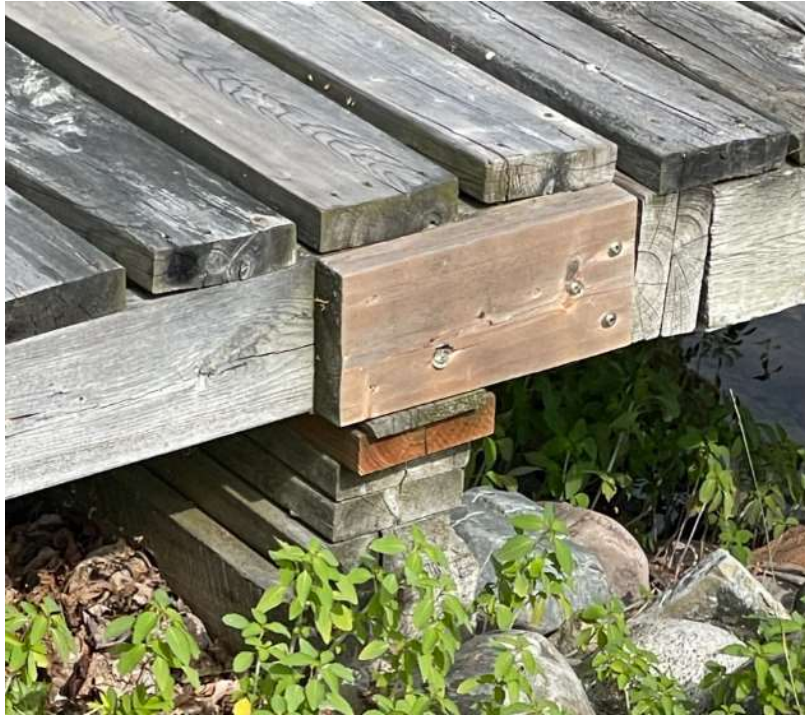
**Photo 6: Wood Shim Support on Underside of Dock Structure**

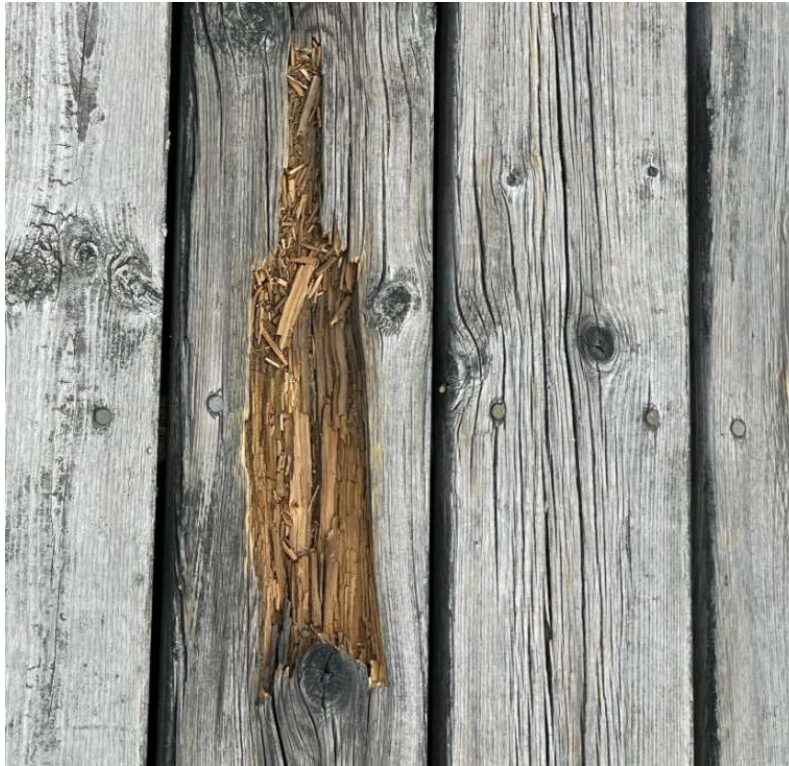
- The lifespan remaining on the wood boardwalk is less than five years.
- The wood boardwalk and guard at the top of the breakwater was in very poor condition and closing it immediately to public access is recommended.
- There was lighting along the boardwalk.
- The pedestrian bridge from the breakwater to a viewing platform was a combination of steel and wood construction.
- The wood surface of the viewing platform and wood guard were noted to be in very poor condition.

**Photo 9: Decayed Wood on Boardwalk**

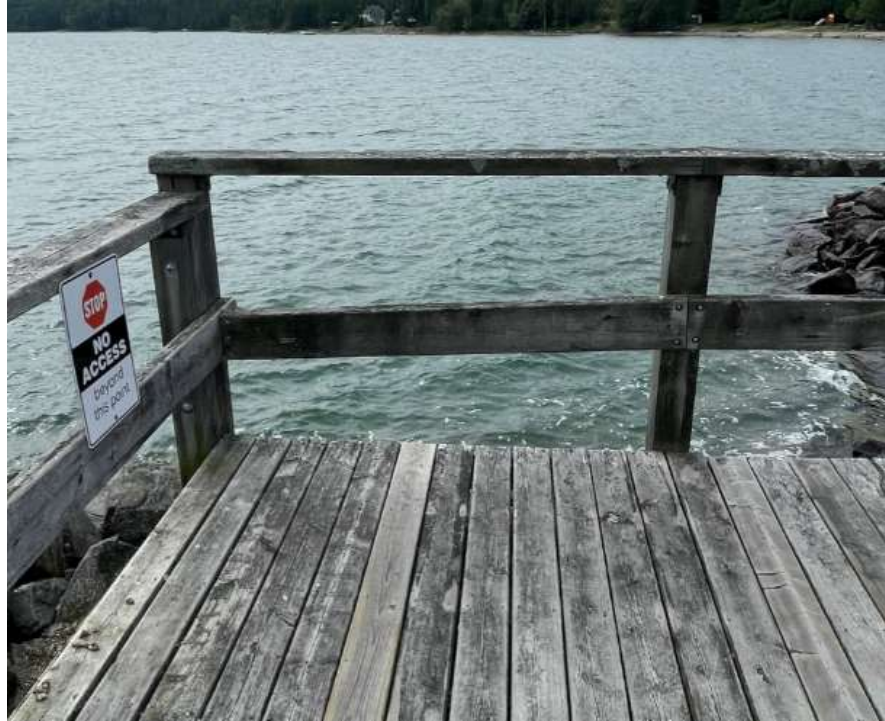
**Photo 11: Loose Guard at Viewing Platform**
