# Village of Hilton Beach

## Asset Management Plan — Phases One and Two

## **VISUAL BUILDING CONDITION ASSESSMENT**

**3100 Bowker Street, Municipal Office, Village  
of Hilton Beach, Ontario**

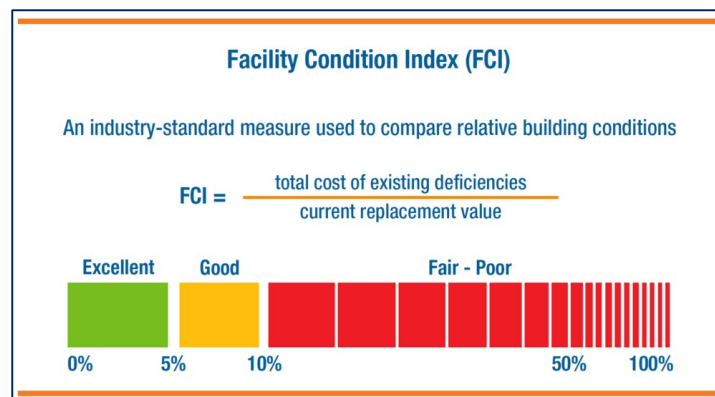
Figure 2 – Facility Condition Index

Facility Condition Index (FCI) is a scale used to assist in building management to assess the general condition of the building. The FCI is calculated by taking the total cost of the existing deficiencies (over the next 10 years) divided by the current replacement value of the building. The Village of Hilton Beach Municipal Office has an FCI value of (3.26%) or is in (excellent) condition.

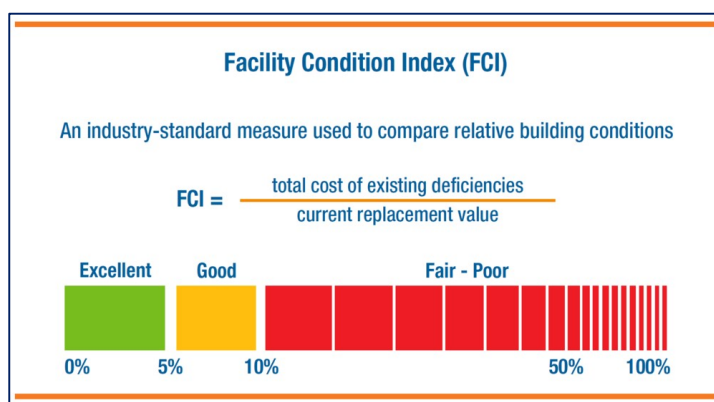
Figure 2 – Facility Condition Index

Facility Condition Index (FCI) is a scale used to assist in building management to assess the general condition of the building. The FCI is calculated by taking the total cost of the existing deficiencies (over the next 10 years) divided by the current replacement value of the building. The Village of Hilton Beach Municipal Library has an FCI value of (12.25%) or is in (fair) condition.

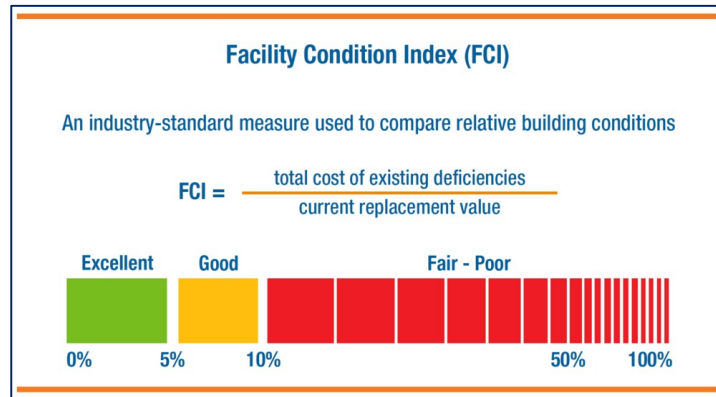
**Figure 2 – Facility Condition Index**

Facility Condition Index (FCI) is a scale used to assist in building management to assess the general condition of the building. The FCI is calculated by taking the total cost of the existing deficiencies (over the next 10 years) divided by the current replacement value of the building. The Village of Hilton Beach Municipal Garage (original garage) has an FCI value of (6.9%) or is in (good) condition.

The new garage has not been given an FCI rating due to it being constructed within the last five years.

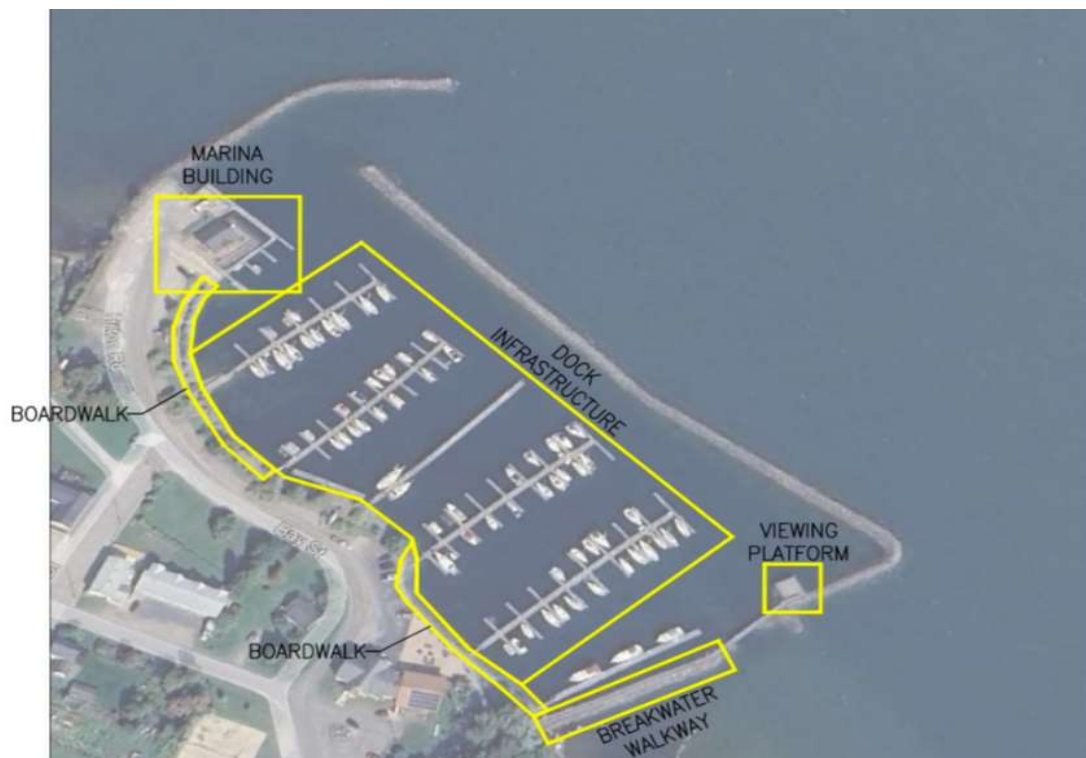
**Figure 1: Dock Infrastructure (Aerial Imagery from Google Earth)**

The boardwalk generally extends from the south extent of the marina basin, north to the marina building. The breakwater walkway extends from the south end of the boardwalk to the bridge servicing the viewing platform (refer to figure 1 for general arrangement of marina infrastructure). The total length of the boardwalk is 260 meters. The total length of the breakwater boardwalk is 110 meters. The total area of the viewing platform is 36 squared meters. It is recommended that the bridge on the breakwater walkway be added to the Municipal bridge appraisal program, and as such, it has not been included in this assessment.

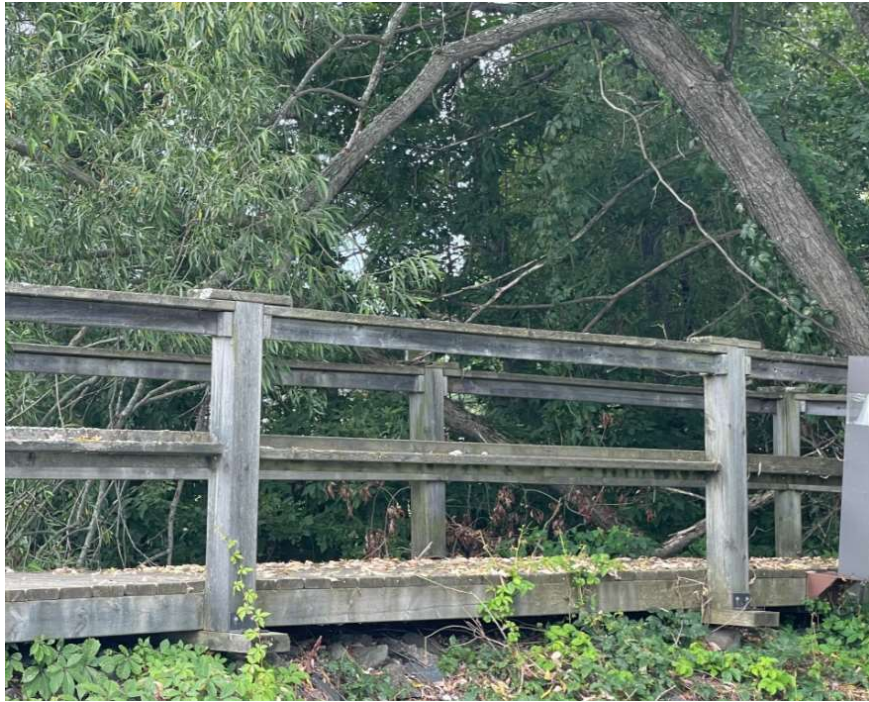
**Photo 7: Boardwalk Access**

The boardwalk, breakwater walkway, and viewing platform are in poor condition overall. During the visual assessment of the building components, several defects were observed and noted. A summary of these observations and defects are listed below:

- The lifespan remaining on the wood boardwalk is less than five years.
- The wood boardwalk and guard at the top of the breakwater was in very poor condition and closing it immediately to public access is recommended.
- There was lighting along the boardwalk.
- The pedestrian bridge from the breakwater to a viewing platform was a combination of steel and wood construction.
- The wood surface of the viewing platform and wood guard were noted to be in very poor condition.

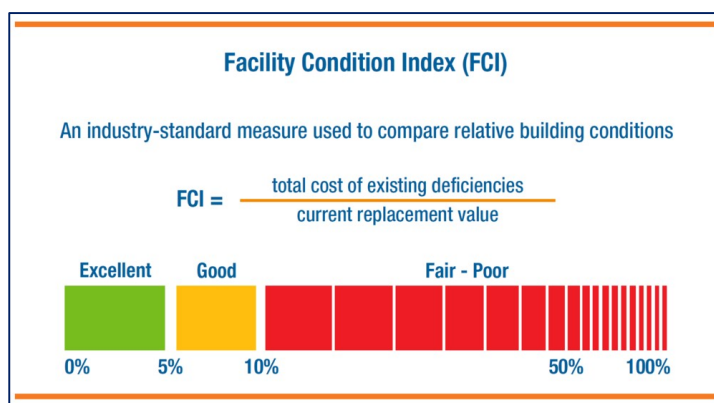
Figure 2 – Facility Condition Index

Facility Condition Index (FCI) is a scale used to assist in building management to assess the general condition of the building. The FCI is calculated by taking the total cost of the existing deficiencies (over the next 10 years) divided by the current replacement value of the building. The Village of Hilton Beach Marina Building has an FCI value of (3.6%) or is in (excellent) condition. The value is applicable to the building proper only. The dock infrastructure has not been included.
